**Water Loss Test Results for the Pipeline Units:
I-19/I-18, I-7A and I-22
Hidalgo County Irrigation District No. 2**

**Texas Water Resources Institute Technical Report
October 2008**

Report Prepared by:
Eric Leigh and Guy Fipps, P.E.¹
June 1, 2007

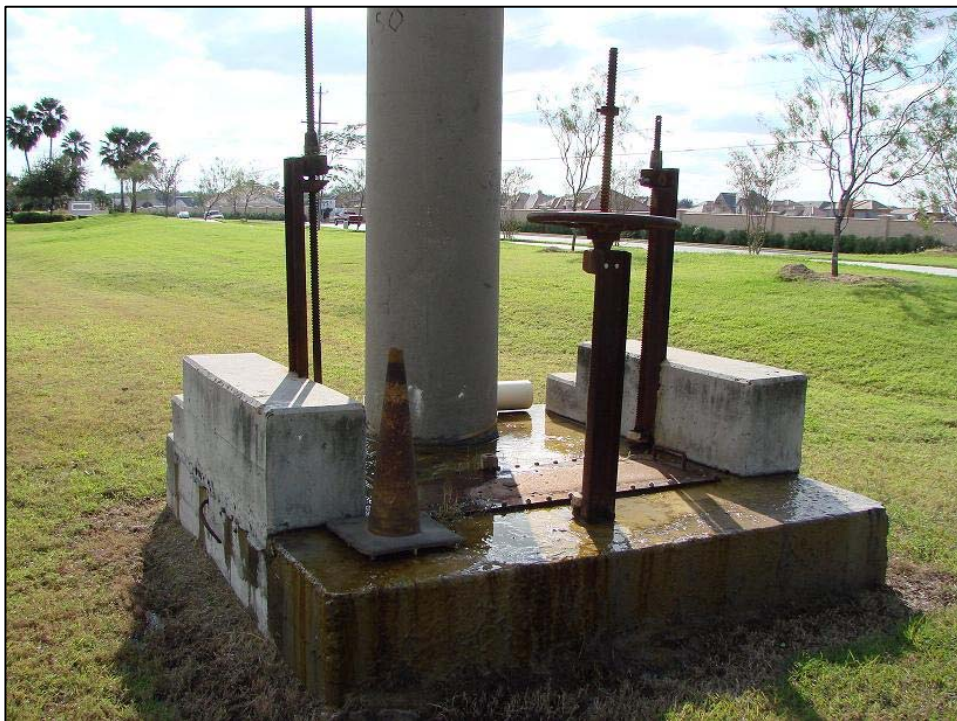
Figure 1 shows a leaking pipeline control structure and standpipe with lateral gates that were shut-off during the test.

Figure 1. Leaking pipeline control structure

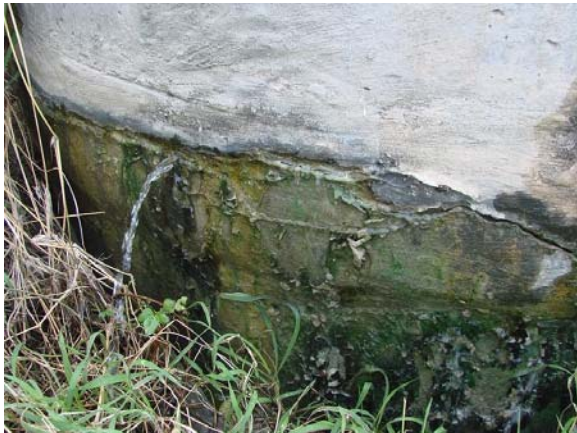
The pipelines were tested using the ponding method. These tests accounted for all the leaks occurring from gates, valves, and pipeline joints that are either undetectable or are difficult to measure (figures 6 and 7), classified as *total loss* tests; thus, measuring the total water loss rate.

Figure 6. Leaking from standpipe

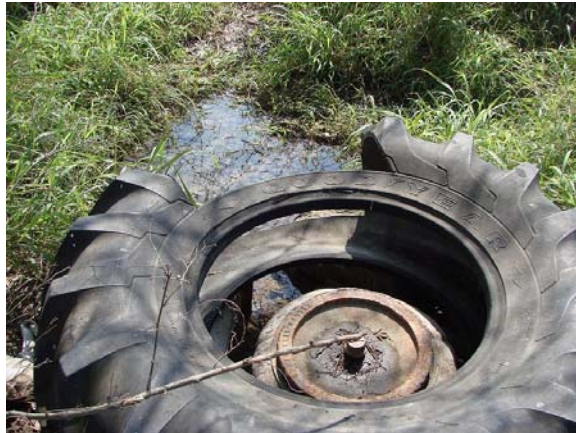
Figure 7. Leaking from turnout valve
