Airborne Multi-Spectral Remote Sensing for Canal Leak detection

Water leaks from canal channels need to be monitored in such a large area of irrigated lands in the Valley. A rapid and effective method is necessary to detect water leaks over the irrigation distribution networks.

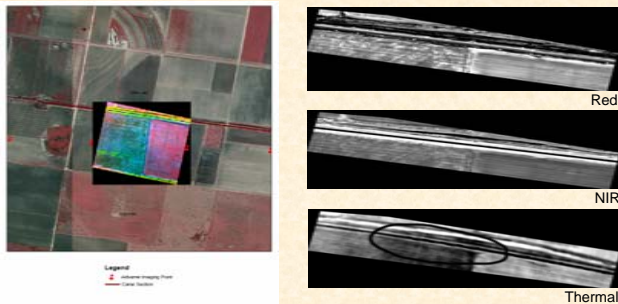
1. Three major leaks in concrete sections matches with image analysis

The GIS map on the left above shows an airborne composite image on a spot of a canal section in Delta Lake. On the right above the images in red and NIR bands indicate that along the levees of the section present strong vegetation and the general condition of the canal section looks fairly good. However, the circled area in the thermal image presents a much cooler signature than adjacent area. The following two pictures were taken during field inspection in the circled area of the thermal image. A big piece of concrete is missing in the spot. This is a significant point of leak, which matches with the observation in the thermal image. Other than this leak point, the canal section looks in fairly good condition in general. The grass on the levees presents the potential seepage from canal and/or ditch side.

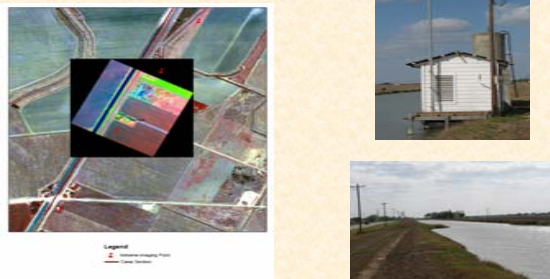
3. Wet areas in earth sections are more difficult to determine because image analysis is easily misled by the mixed signatures of vegetation and moistened spots with less vegetation although a lot of spots, such as strong vegetation, holes, lateral turnout, pump and stand pipes, were identified as potential leak sources.

The GIS map on the left above is an airborne composite image on a spot of an earth canal section in Harlingen. This section is the Harlingen main that is a wide earth canal shown as the picture on the lower right above. The spot was determined as a potential leak source located at a pump station with a stand pipe. However, along the channel the grass is uniformly distributed, which is hard to determine as a result of leak or seepage.

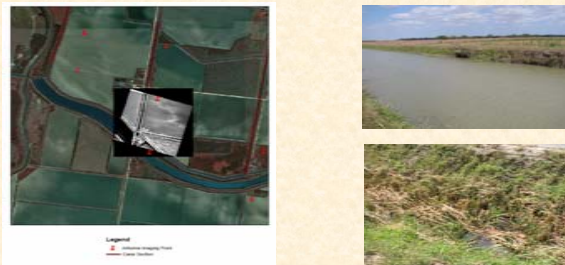
The GIS map on the left above shows an airborne NIR image on a spot of a canal section in San Benito. The picture on the top right indicates a hole on the side of the canal and the picture on the bottom right presents some water on the drainage side. Are they the leak sources? Merely with visual inspection it is hard to determine.

4. Visual field inspection is limited. An objective field inspection method, such as EC (electric conductivity), may be needed in addition to visual inspection.
