SYNTHETIC CANAL LINING EVALUATION PROJECT

Eric Leigh¹
Askar Karimov²
Guy Fipps, Ph.D., P.E.³

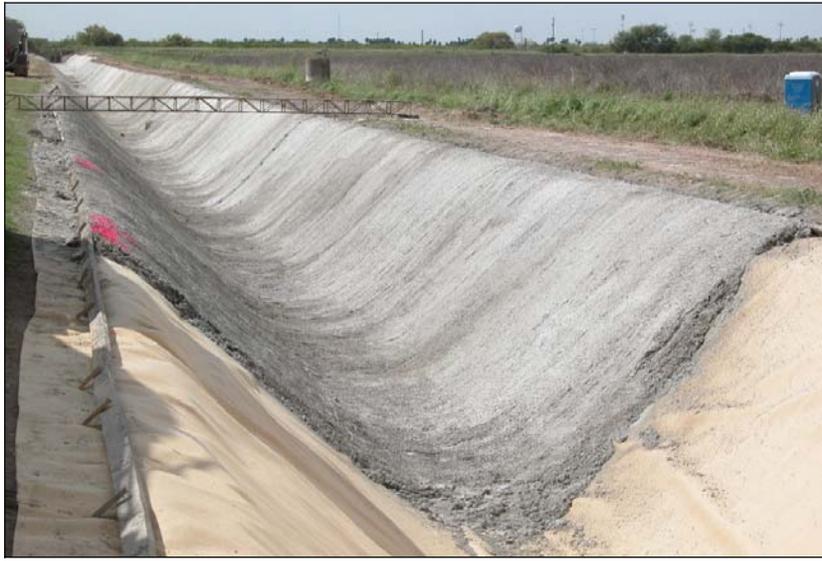
The best performers were the synthetic liners with a layer of shotcrete. This system is effective as the liner reduces seepage losses dramatically, while the layer of shotcrete prevents damage to the liner. Five projects extending over about 17 miles were implemented using this system with two different liners: polyester and PVC. The protective barrier consisted of 2 - 3 inches of shotcrete as shown in Figure 2.

To-date, these projects show no evidence of problems and have required no maintenance. No difference in performance was observed between the two types of liners. Hairline cracks developed in the shotcrete on a small stretch of Project #5, but no related problems have been observed.

Figure 2. Polyester canal liner with a 3-inch protective barrier

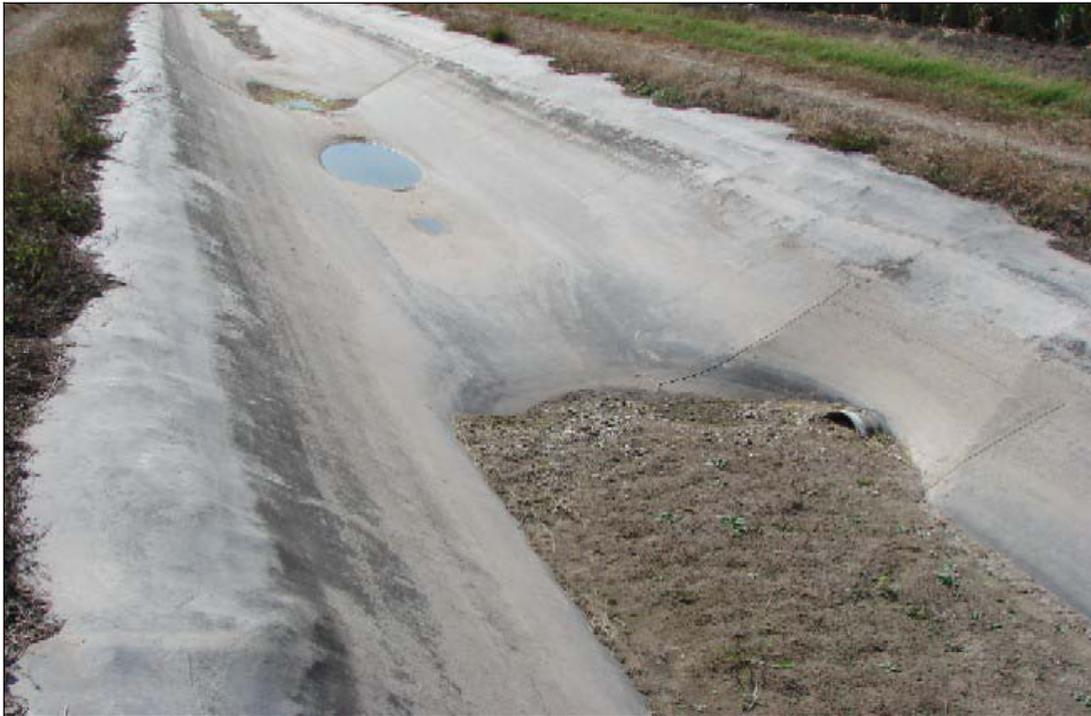
Installation and maintenance of the liners also appears to explain some of the variation in performance of these projects as discussed below. Another consideration with exposed liners is the potential damage that machinery can cause during normal district mowing operations and while cleaning out aquatic vegetation and sedimentation (Figure 3).

Figure 3. Aquatic vegetation and sedimentation clogging a farm outlet pipe

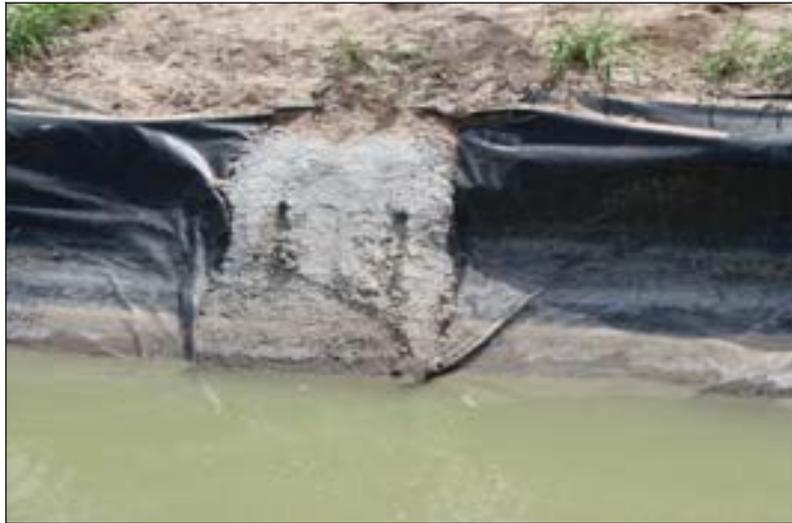
For the project shown in Figure 4, concrete sections approximately 1-foot wide were poured on top of the liner at a spacing of 500 feet. The rationale is that the concrete sections will help keep the liner in place and provide access points for sediment removal. Our conclusion is that long-term evaluation is needed to determine if such sections are useful for these purposes.

Figure 4. Concrete sections poured on top of a polypropylene liner

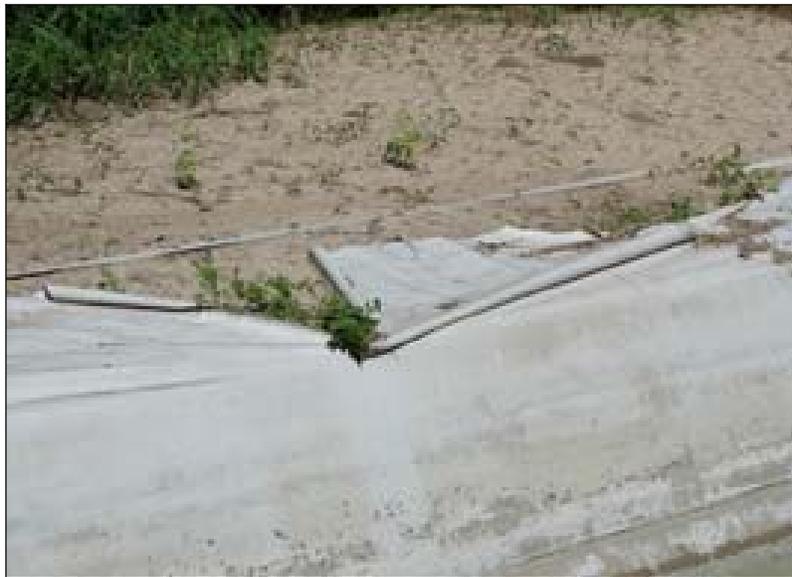
PVC Alloy Three short sections of PVC alloy were installed in 1999, ranging in length from 38 to 148 ft. This material has performed well, requiring little maintenance, with no major damage observed. However, cuts and tears have occurred in the exposed area of the liner (Figure 5) which could develop into larger problems if not taken care of in a timely manner. The overall performances for these small test segments are excellent to good.

Figure 5. PVC Alloy liner damaged on the exposed area

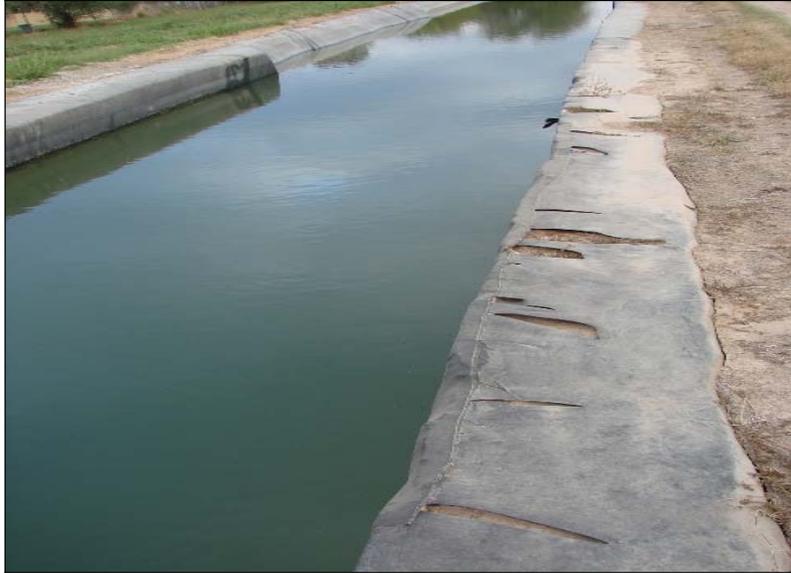
many cuts and tears initially occurred on the exposed areas where there is the most human and animal traffic (Figure 6). Unless repaired in a timely manner, these tears may lead to increasing amounts of damage (Figure 7).

Figure 6. Cuts/tears in a rubber liner

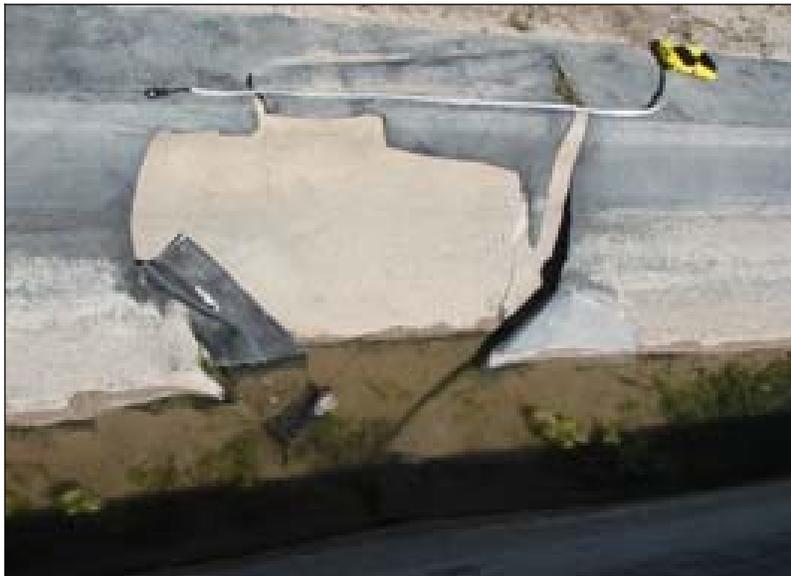
Figure 7. A rubber liner damaged possibly due to vandalism

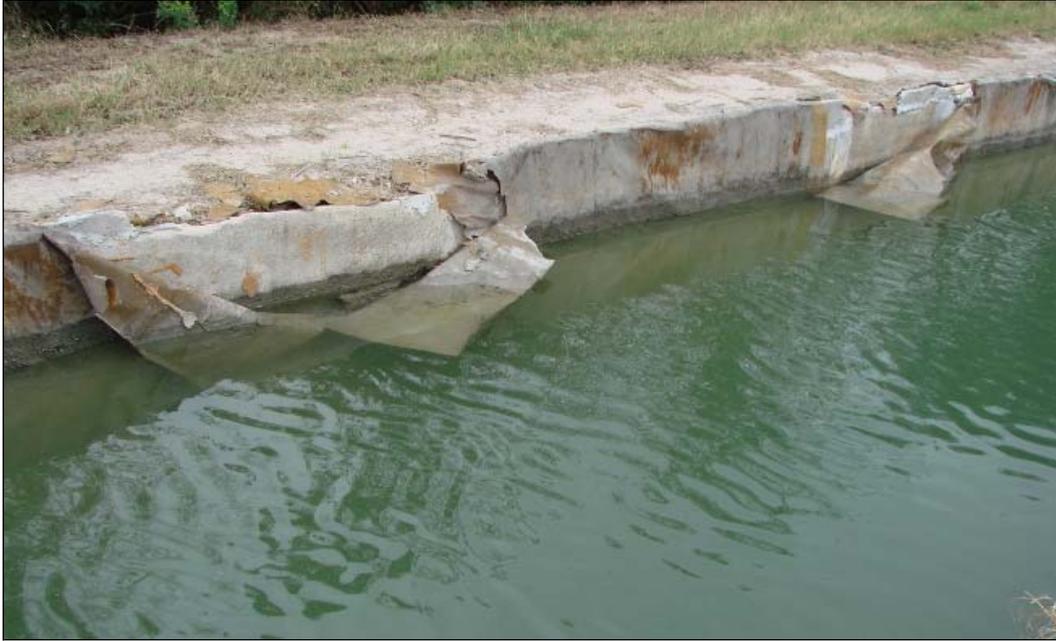
Polyurethane During 1999 - 2000, nine short sections were lined with polyurethane, totaling 1.42 miles. The current condition of these projects varies from excellent to serious problems, with one section a total failure. Observed problems include the liner falling off the canal walls which was likely caused by a combination of severe UV damage (Figure 8), material defects, and vandalism. In some segments, the top layer of the material has peeled off, while in others, the entire liner has worn off (Figure 9).

Unlike the other liners, the polyurethane was manufactured on-site by specialized machinery, and requires that the chemicals used to be properly handled. Several problems occurred during its manufacture and installation, including inconsistency in product thickness, which may account for the large variation in performance. In addition, little to no maintenance has occurred since installation.

Figure 8. Polyurethane liner is shown hanging off the canal wall.

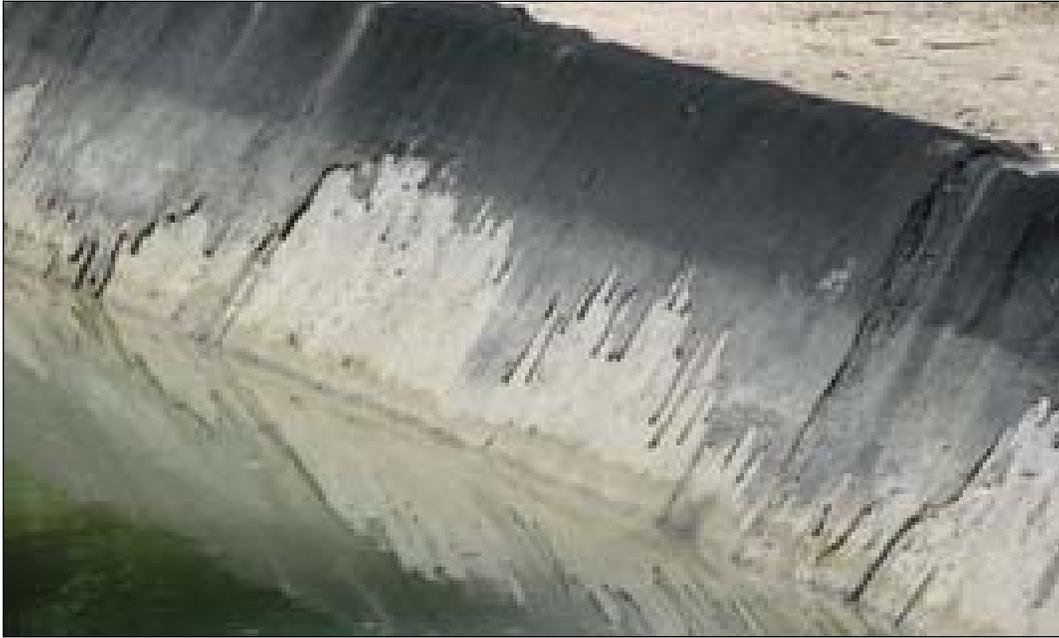
Figure 9. Residue left from a deteriorated polyurethane liner

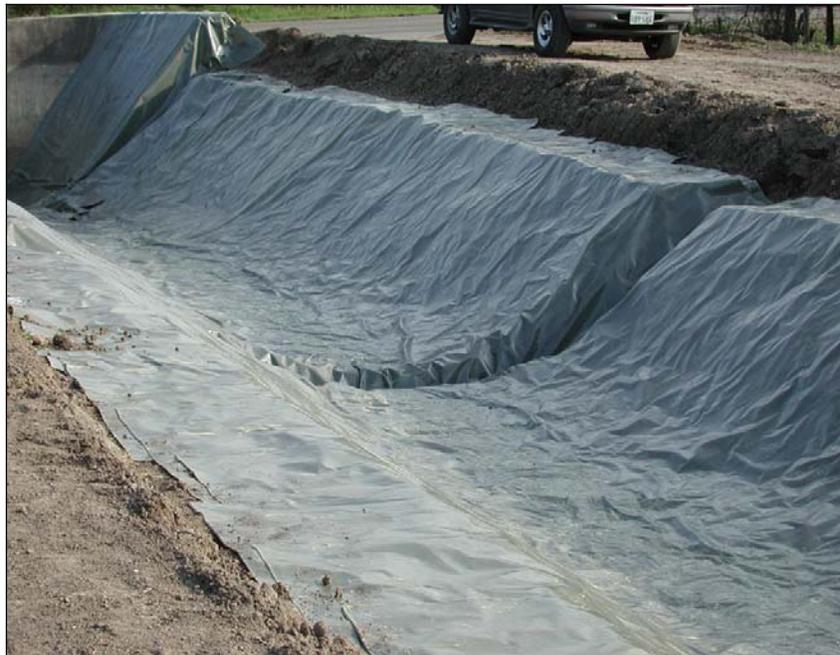
In one of early lining projects, the liner size was not planned properly to overlap and extend onto the top of the levee (Figure 11). As seen in Figure 12, the operating depth of the canal was higher than the top of the liner. The water eventually got underneath this liner and caused it to float.

Figure 11. Canal liner installed too low on the levee

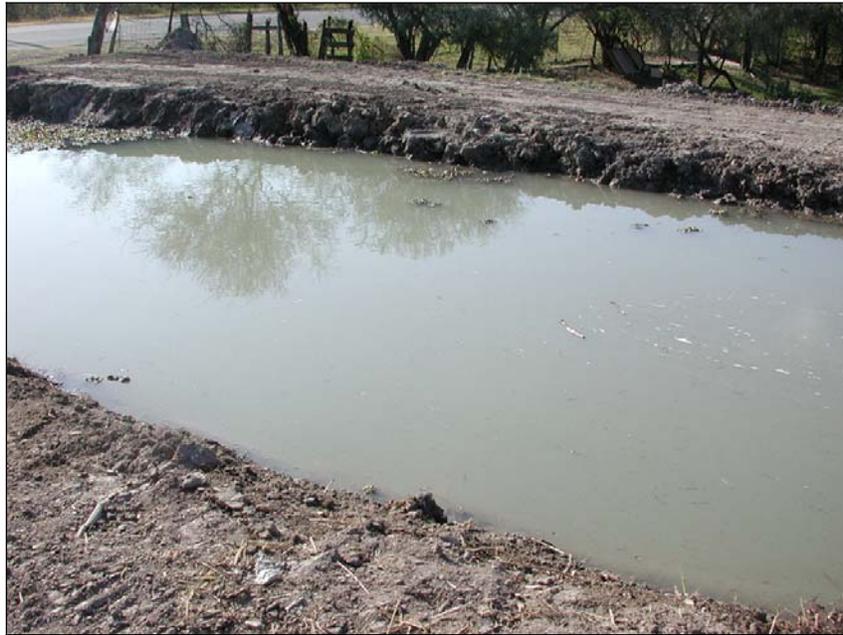
Figure 12. Water level higher than the canal liner installed

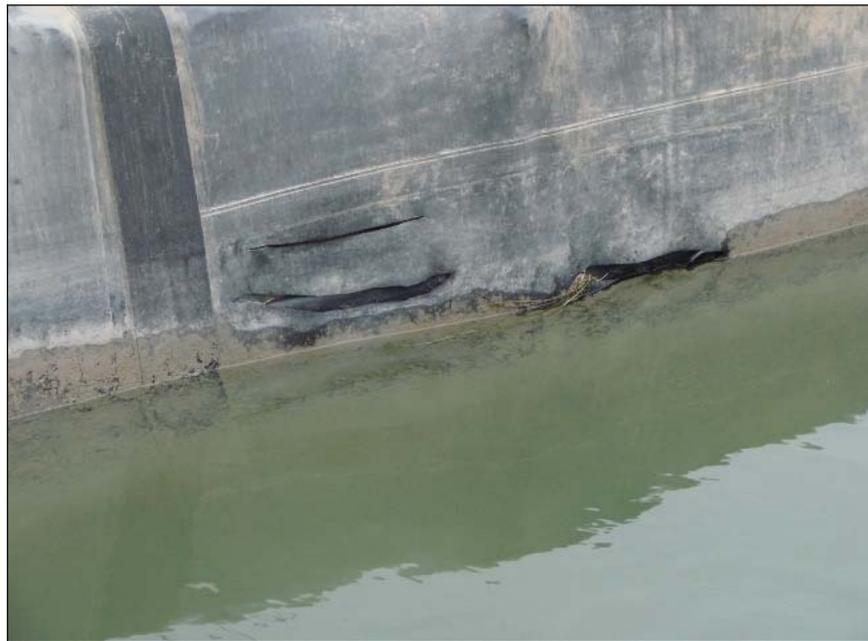
Most damage has occurred on the exposed areas of the liner and top side walls of the canal. Figure 13 shows a cut made with a sharp object (probably intentional vandalism) versus Figure 14 could have been a case of unintentional vandalism. In areas where kids are playing, swimming in the canals, or being mischievous, intentional and unintentional vandalism will occur. Vultures have been reported to pick at the seams on the EPDM Rubber; animal hoofs can cut some liners.

Figure 13. Horizontal cuts likely due to vandalism on the canal sidewall

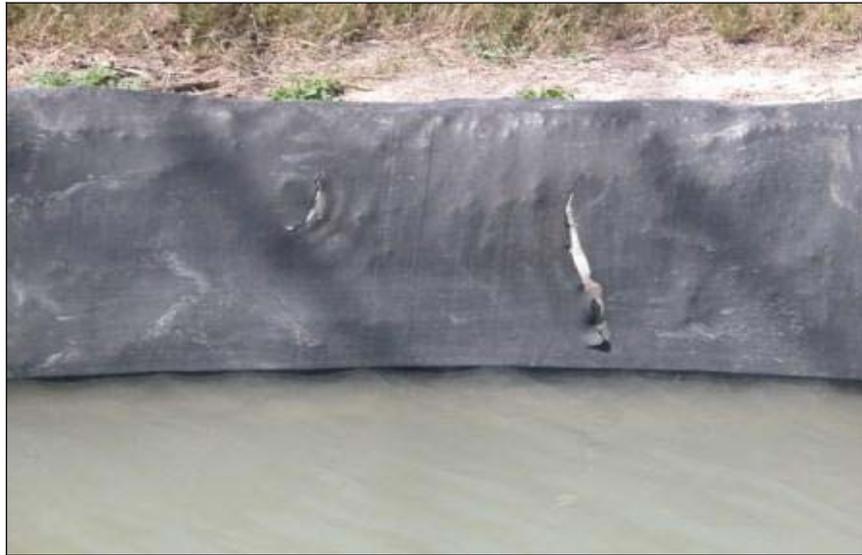
Figure 14. Vertical cut or tear on canal side wall caused unintentionally

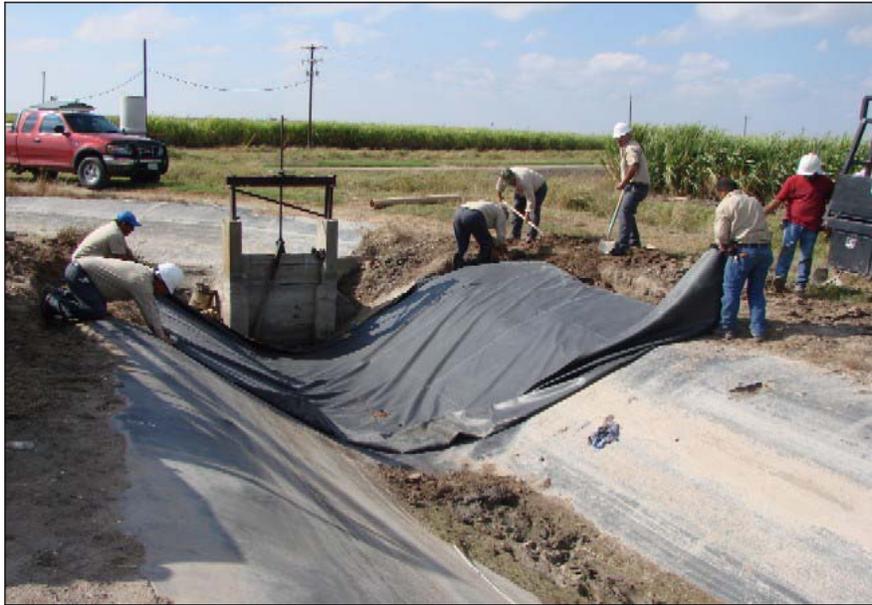
Figure 16. A district maintenance crew repairing a damage section of lining

A regular inspection and maintenance program is important so that repairs can be completed on a time basis. Once a tear or cut starts, it will tend to expand or be susceptible to further damage until it is repaired. Districts should consider having their personnel trained to performed the repair and maintenance which sometimes requires specialized equipment, and similar glues and adhesives used during the installation process (Figures 16 and 17). Removing sediment from lined canals may be more difficult due to the limitations of using heavy machinery, and may require increased manual labor (Figure 18).

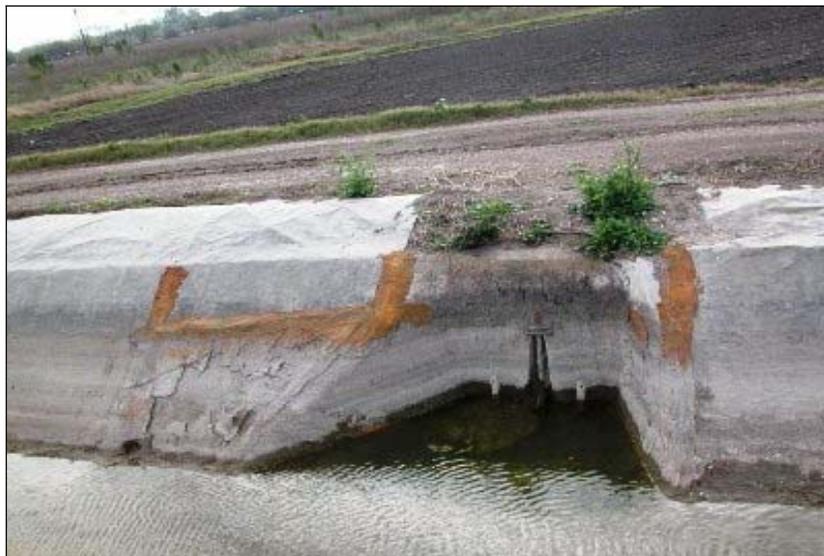
Figure 17. Repair of the liner joints around a structure with glue

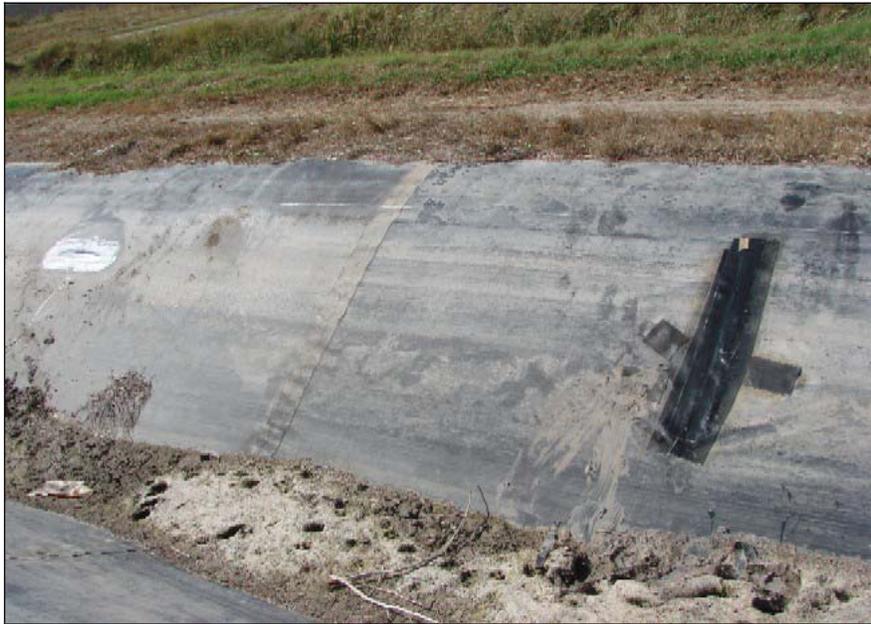
Figure 18. Sedimentation at the bottom of a lined canal
