AIRBORNE REMOTE SENSING FOR DETECTION
OF IRRIGATION CANAL LEAKAGE^{†,‡}YANBO HUANG^{1*}, GUY FIPPS², STEPHAN J. MAAS³ AND REGINALD S. FLETCHER⁴¹*Agricultural Research Service, United States Department of Agriculture, Stoneville, Mississippi, USA*²*Department of Biological and Agricultural Engineering, Texas A&M University, College Station, Texas, USA*³*Department of Plant and Soil Science, Texas Tech University, Lubbock, Texas, USA*⁴*Agricultural Research Service, United States Department of Agriculture, Weslaco, Texas, USA*

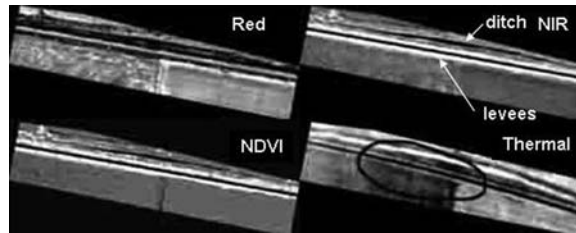
Case 1 is a concrete canal section in the Delta Lake Irrigation District (Site 3 in Table II). Red and NIR images indicated a wide drainage area along the canal (Figure 4) and a significant amount of vegetation on the canal levees. The NDVI image, which enhances the signatures of the vegetation, showed significant vegetation on the levees and in the drainage ditch (bright part on the image), and bare soil (i.e. no crops) in the adjoining fields. The thermal image presents a much cooler signature at a location on the south (bottom) side of the canal than in the adjacent area (circled in Figure 4), which is likely the location of a leak.

Figure 4. Airborne multispectral images of a concrete canal section in the Delta Lake Irrigation District (Case 1). The circled area in the thermal image showed a significantly cooler area – a large missing piece of concrete lining resulting in a major leak

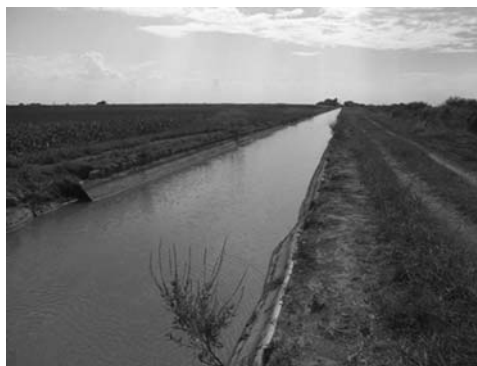
Figure 5 shows a ground-level photo of Site 3. The wide drainage area was on the north (right) side of the canal section under the thick bushes. The canal section appeared to be in fairly good condition. The grass on the levees is an indicator of seepage from the canal. The actual leak is located on the south (left) side of the canal and consisted of cracks and a large missing piece of concrete lining and corresponds to the thermal image indicator shown in Figure 4. Conclusions of the field reconnaissance were that there were both a major leak here and high levels of seepage as indicated by grass and bushes present in the area.

Figure 5. Ground-level photograph of a concrete canal section in the Delta Lake Irrigation District (Case 1)

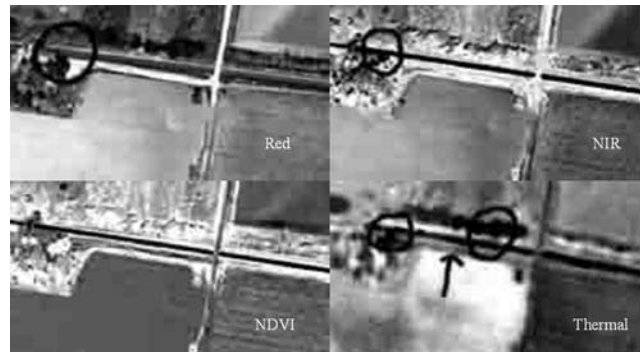
The second case study illustrates the usefulness of using multispectral images in order to filter out false positives. Site 4 (Table II) is also a concrete canal segment in the Delta Lake Irrigation District. The red, NIR, and thermal images (Figure 6) indicated that the canal section was in fairly good condition, with two areas indicating possible problems. On the red and the NIR images, the circled areas represent dense vegetation, whereas, on the thermal image, they represented areas of low temperature, which may be related to wetness. However, the corresponding NDVI image generated from the red and NIR images revealed a large tree and its shadow between the tree and the canal. Also, the NIR image indicates dense vegetation along the levee and in the adjacent area, a signature of seepage.

Figure 6. Airborne multispectral images of a concrete canal section in the Delta Lake Irrigation District (Case 2). The circled areas in the images show dense vegetation and surrounding areas, which was proven to be a tree and its shadow. NDVI with NIR and red images could differentiate the tree and shadow, but the thermal image could not

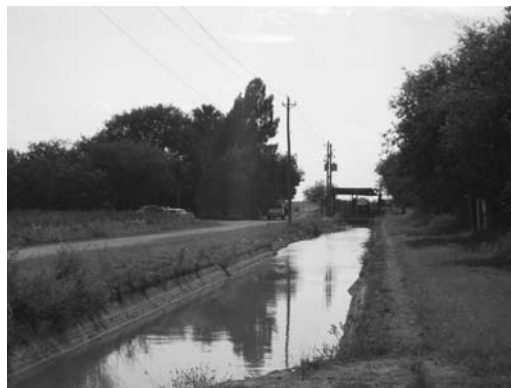
This interpretation was confirmed during field reconnaissance as shown in the ground-level photograph (Figure 7) which shows the canal segment in fairly good condition. The photograph also shows the tree and shadow which is not related to the seepage or leakage, and the vegetation which indicates seepage problems. This case explained how images obtained in other regions of the spectrum help avoid misleading information provided by the thermal image.

Figure 7. Ground-level photograph of a concrete canal section in the Delta Lake Irrigation District (Case 2)

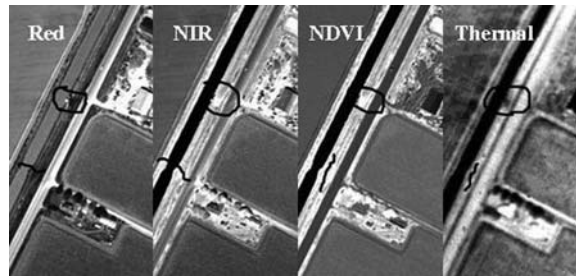
The third case illustrates a different type of problem which is easily identified through image analysis. Site 20 (Table II) is an unlined canal segment in Harlingen Irrigation District. While the canal segment appears to be in good condition (Figure 8), the red image indicates some sort of structure or artefact around the circled area, and the thermal image shows a low temperature signature here as well. The wavy line in all four images indicates dense vegetation in this area.

Figure 8. Airborne multispectral images of an earth canal section in Harlingen Irrigation District 2 (Case 3). The circled location was a standpipe structure and the marked lines showed dense vegetation

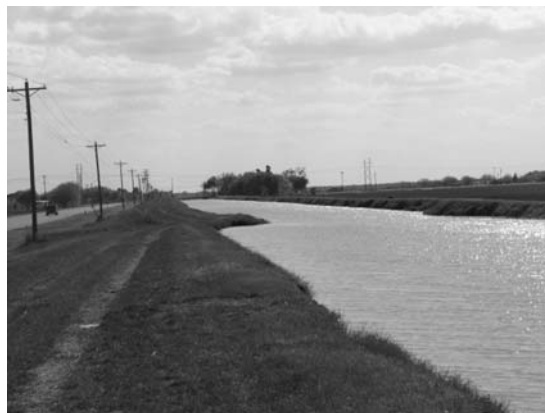
Field reconnaissance gave the site a visual rating of 6, meaning that the site may have a problem with a leak. The ground-level photograph (Figure 9) verifies that the canal segment was in fairly good condition, and grass grew uniformly along the sides of the channel (wavy lines in Figure 8). The circled area in the figure was a structure (i.e. a standpipe and valve) used to divert water into a pipeline system. Some seepage was occurring on the east side of the building as indicated by the imagery. The seepage was caused by the operation of the structure. It was concluded that a seepage problem existed at this site. It was mainly caused by the operation of the water distribution system.

Figure 9. Ground-level photograph of an earth canal section in Harlingen Irrigation District 2 (Case 3)
