**FLOW MEASUREMENT STRUCTURE  
ASSESSMENT  
IN  
RICHMOND IRRIGATION DISTRICT**

# Flow Measurement Structure Assessment

Report prepared for the  
Richmond Irrigation District

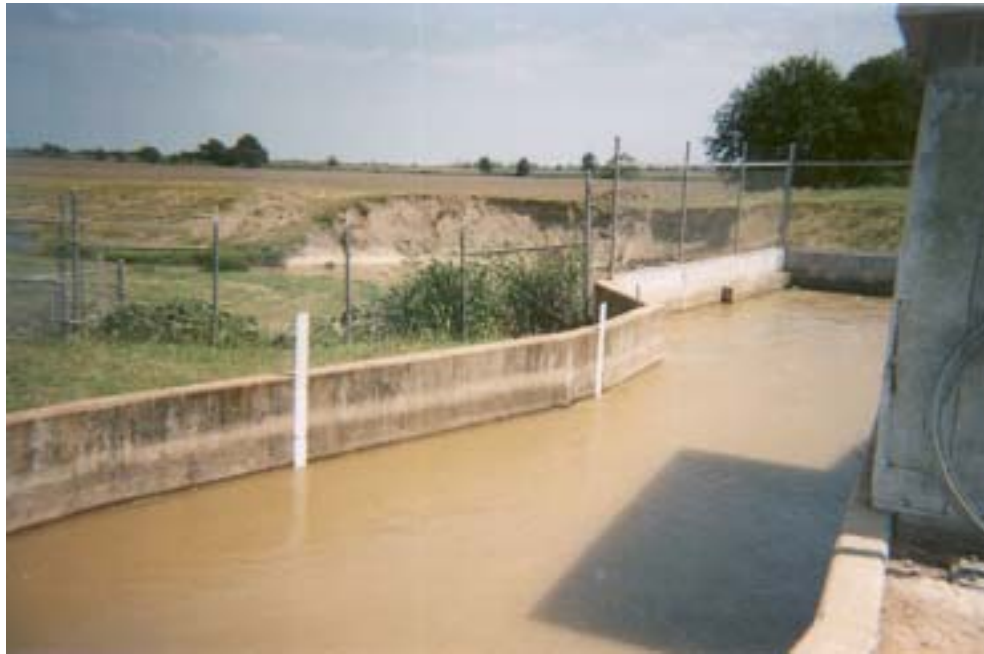
Figure 1: 10 foot Parshall flume and water level of flow measurement on May 16, 2003.
