PONDING TESTS AND RESULTS

Ponding Test Procedures

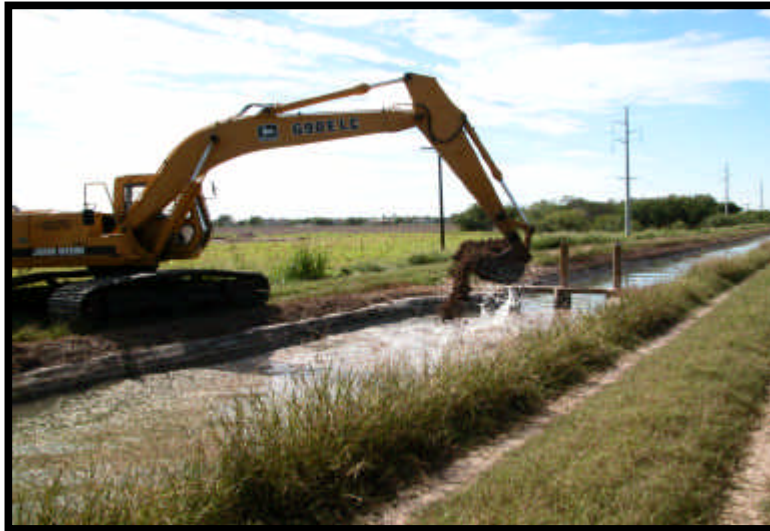
Figure A2. Typically, the irrigation district provides the equipment and constructs the earthen dams used to block off the ends of the test segment.

In the ponding test method, two ends of a canal segment are closed or sealed with earthen dams shown in Figures A2 and A3. Once sealed, water elevations are taken for approximately 48 hours. Two to three staff gauges (Fig. A4) are placed in each test segment, and stage levels are recorded manually. Canal dimensions and water spans are also surveyed during the test.

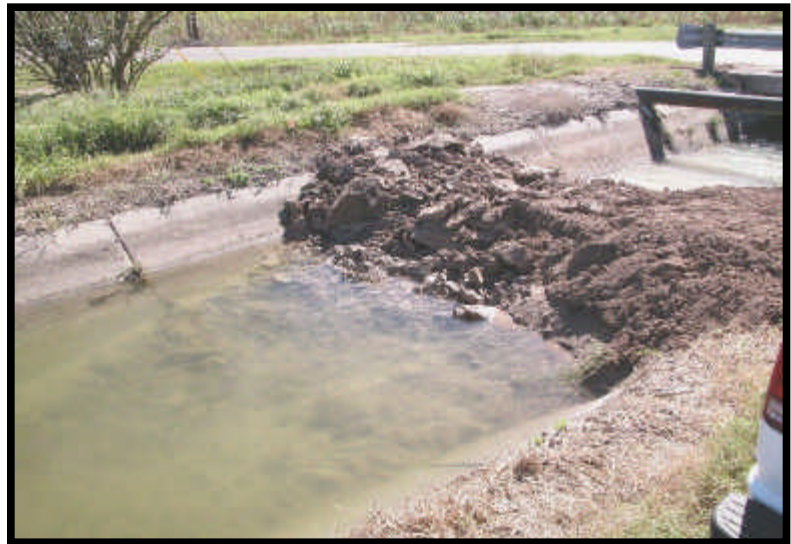
Figure A3. Close up of an earthen dam used in ponding tests.

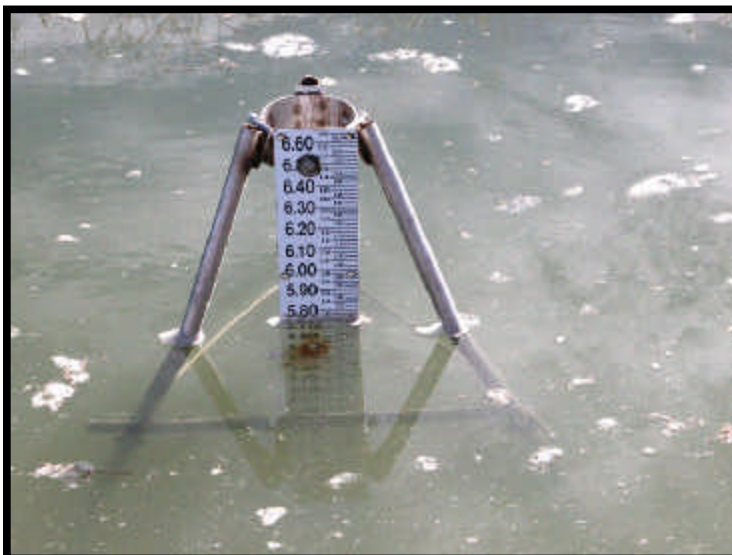
Figure A4. Free standing staff gauge used to record changes in water levels during test.
