AIRBORNE MULTISPECTRAL REMOTE SENSING IMAGING FOR DETECTING IRRIGATION CANAL LEAKS IN THE LOWER RIO GRANDE VALLEY

Yanbo Huang and Guy Fipps

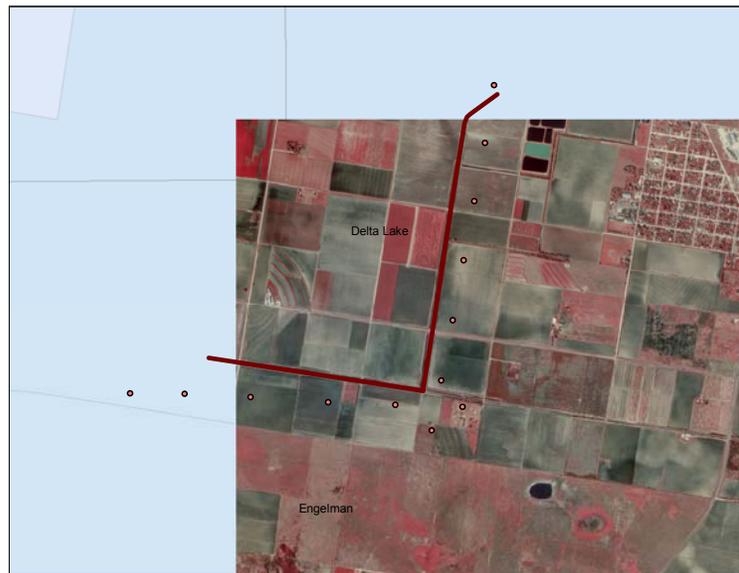
Figure 2. GIS map showing the imaging points over the canal segment in Delta Lake.

The GIS map shows find that some of the imaging points may be out of the area of interest. Figure 2 indicates that among the thirteen imaging points, three of them are out of the area. Then, through quality checking, it was found that there seems to have an occasional glitch with the system, as sometimes the image from the Dalsa 1 and/or 2 cameras were not correctly recorded. So, these out-of-area images and glitched images are excluded in image processing. The rest of the images are considered effective. Figure 3 shows the sequence and the condition of the imaging points over the Delta Lake canal segment. It indicates that besides three out of area imaging triples, there are three defect imaging triples. Seven imaging triples are effective and left for processing.

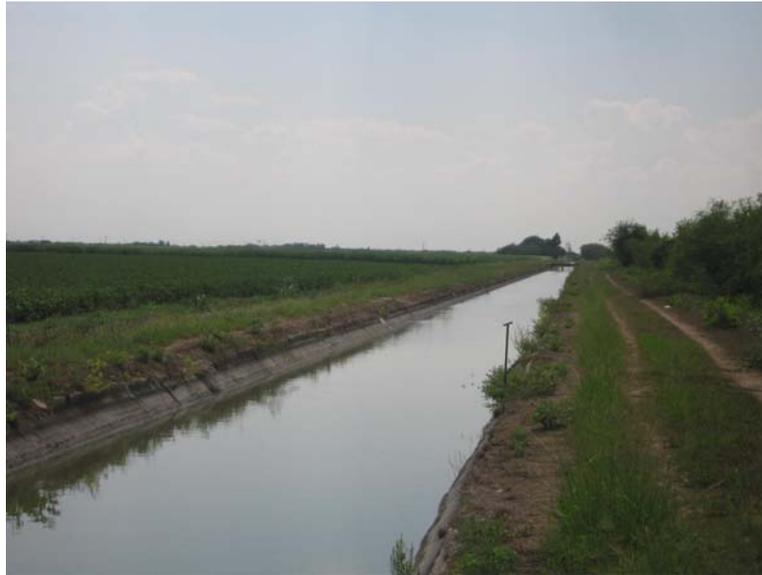
On June 28, 2005, field reconnaissance was performed on four concrete canal segments in Delta Lake, Mission, United and Merced. Figure 5 is the picture of the canal segment under the imaging point FID 113. The drainage ditch is on the right side of the canal under the thick bushes. The canal section seemed to be in fairly good condition in general. The grass on the levees presents the potential seepage from canal and/or ditch side. On the right side of the canal, the grass came out around the structure and from the cracks of concrete, which are the points of leaks. The thermal image presents signatures on that also.

Figure 5. Picture of canal segment under the imaging point FID 113.

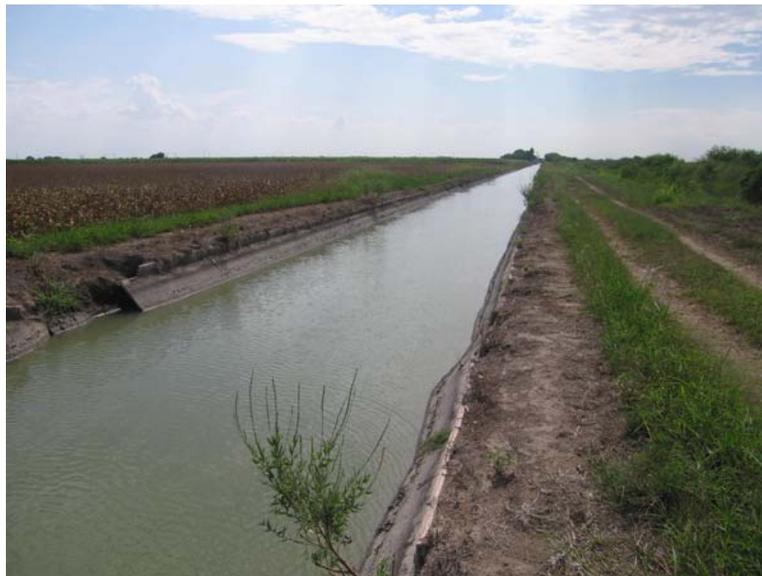
Figure 7 shows the canal segment under the imaging point FID 114. The drainage ditch is on the right side of the canal under the thick bushes. The canal section did look in fairly good condition in general. The grass on the levees presents the potential seepage from canal and/or ditch side. At the beginning on the left side of the canal there is a big hole on concrete, which should be a significant point of leak. The thermal image presents a cooler signature in that area.

Figure 7. Picture of canal segment under the imaging point FID 114.

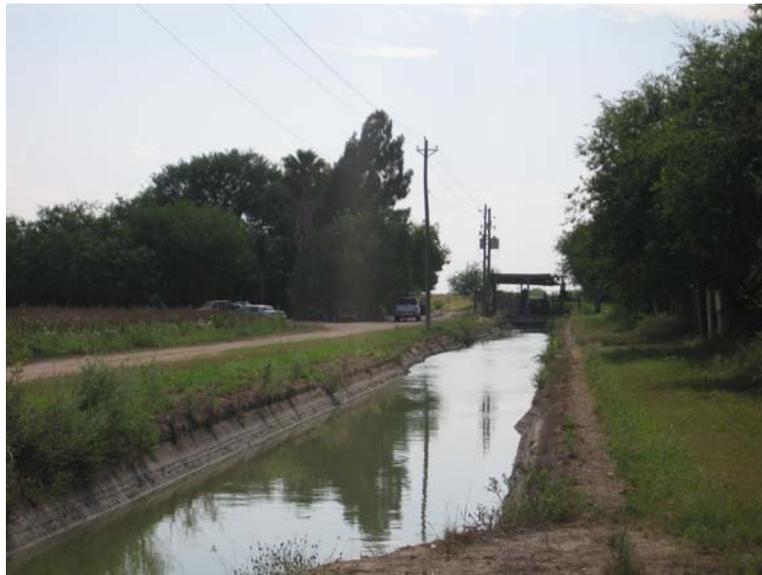
Figure 9 shows the canal segment under the imaging point FID 115. The canal section did look to be in fairly good condition in general. The south side of the canal had more grass than the north side, which implies the south side had more seepage or leaks. The picture also shows the tree and the shadow between the tree and the canal, which can not relate to the seepage or leak.

Figure 9. Picture of canal segment under the imaging point FID 115.
