**Water Loss Test Results for the Pipeline Units:
I-19/I-18, I-7A and I-22
Hidalgo County Irrigation District No. 2**

**Texas Water Resources Institute Technical Report
October 2008**

Report Prepared by:
Eric Leigh and Guy Fipps, P.E.¹
June 1, 2007

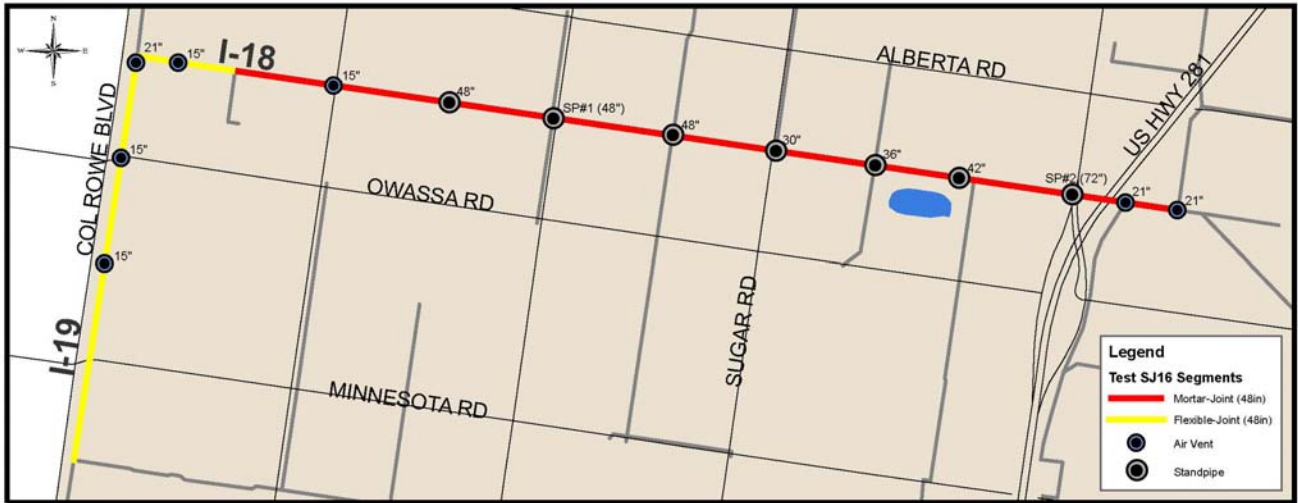
Figure 3. Detailed map of Test SJ16

Test SJ16 included a 1 mile segment of pipeline Unit I-19 and 2.59 miles of pipeline Unit I-18; running north from Nolana Loop, then east from Col. Rowe Blvd, and ending near US Hwy 281 (see figure 3).

- Unit I-19: 1 mile of 48 inch FJRC (Flexible-Joint Reinforced Concrete) pipeline;
- Unit I-18: 0.25miles of 48 inch FJRC pipe, and 2.34 miles of 48 inch MJC (Mortar-Joint Concrete) pipeline.

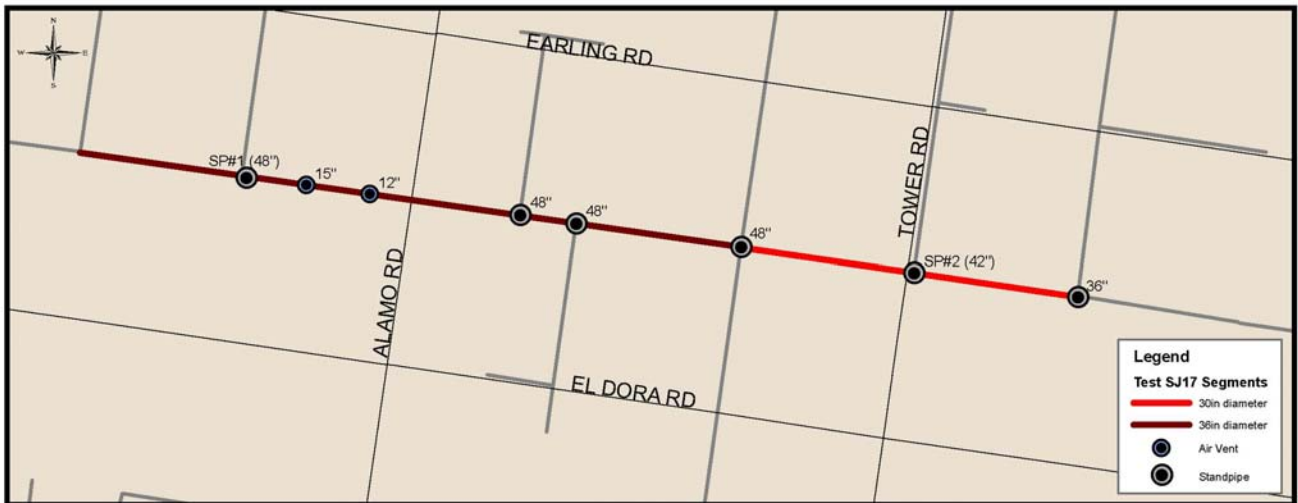
Figure 4. Detailed map of Test SJ17

Test SJ17 tested 1.5 miles of the mortar-joint pipeline Unit I-7A, consisting of 1 mile of 36 inch pipe, and 0.5 miles of 30 inch pipe. Test the section began east of Cesar Chavez Rd and ending just east of Tower Rd, north of El Dora Rd. (see figure 4).

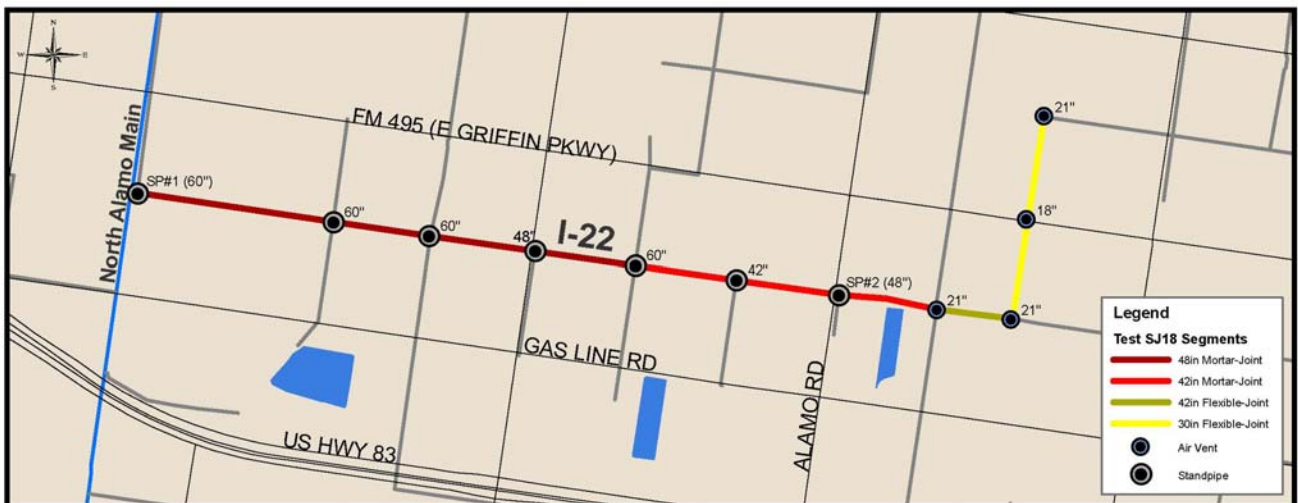
Figure 5. Detailed map of Test SJ18

Test SJ18 tested 2.68 miles of Unit I-22, beginning from the North Alamo Main canal, running east towards Tower Rd, just north of Gas Line Rd. (see figure 5).

- Mortar-Joint: 1.25 miles of 48 inch pipe, and 0.75 miles of 42 inch pipe;
- Flexible-Joint: 0.18 miles of 42 inch pipe, and 0.5 miles of 30 inch pipe.
