Airborne Multi-Spectral Remote Sensing for Canal Leak detection

Water leaks from canal channels need to be monitored in such a large area of irrigated lands in the Valley. A rapid and effective method is necessary to detect water leaks over the irrigation distribution networks.

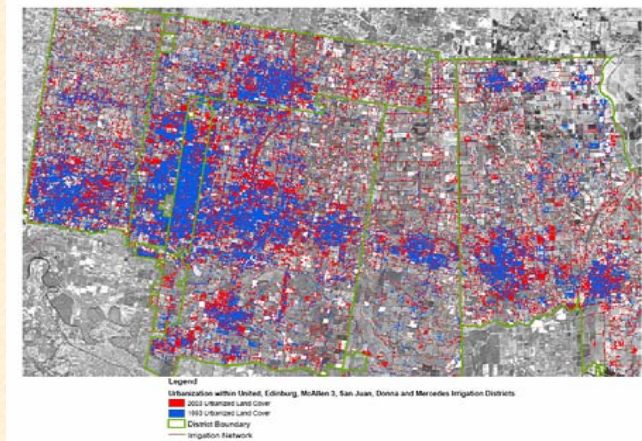
The map below scales down to show the urbanization within the irrigation districts, United, Edinburg, McAllen 3, San Juan, Donna and Mercedes in Hidalgo county. In this area, the urbanization was estimated as an increase of 62% with an increase of irrigated land of 20%.
